REPLANTATION, MULTIPLE TRAUMAS, FISTULA, APEXIFICATION AND APEXOGENESIS, AND INTERNAL BLEACHING

Jason's Tooth

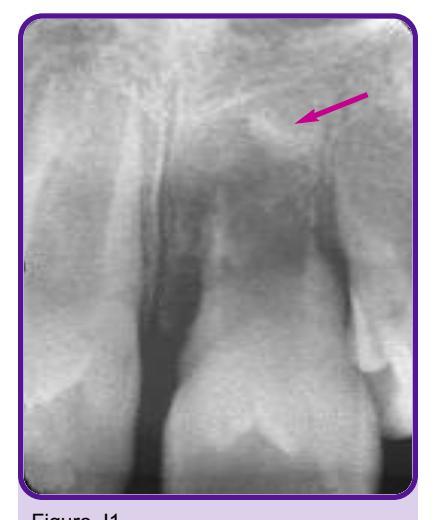
Figure J1 Radiograph reveals an incompletely formed root canal, wide-open apex and a large periapical lesion. Note the apical tooth bud that was separated from the tooth when the trauma occurred. (October 1991)

Our clinic staff noted the fistulous tract, and a radiograph was taken that showed an incompletely formed root, a wide-open apex and a large periapical lesion (*J1*). We also noted an opacity beyond the root, which we later learned was the separated apical tooth bud. The splint, which had been in place for six months, was removed to determine if the tooth was firm, which it was. Since I was not in the clinic at the time, Jason was asked to return in two days so that I could evaluate the case.

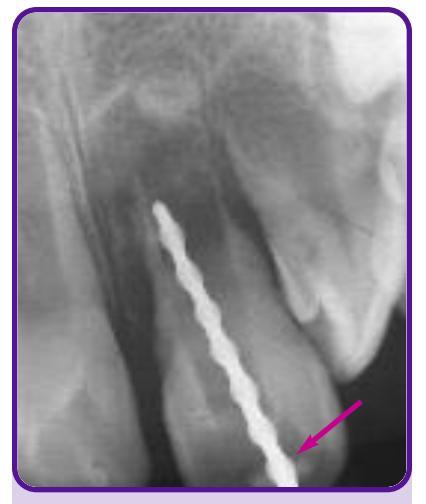
Figure J2 Diagnostic radiograph with #110 file in place. Note the radiopaque stop. (October 1991)

Root canal therapy was performed by entering the tooth from the palatal aspect with a #4 round bur. The opening was then enlarged to make it easier to clean out the canal. Using a #110 file, a diagnostic radiograph was taken to determine the working length (J2). The canal was filed and cleansed and filled with Pulpdent TempCanal, temporary calcium hydroxide canal treatment paste.

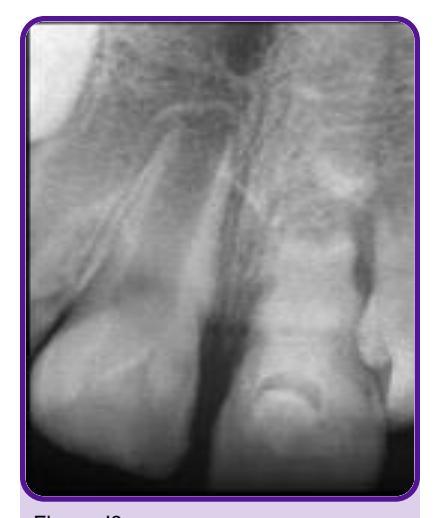
Figure J3 Shows periapical healing, apexification and apexogenesis of the detached apical root bud seven weeks after treatment with TempCanal. (December 1991)

The TempCanal dressing was changed in November and December 1991, at which time clinical examination revealed that the fistulous tract had healed and the tooth was firm. A radiograph was taken which showed periapical healing and calcification occurring at the apex (J3).

I was fascinated to see that apexogenesis was also occurring in the tooth bud that had been separated at the time of the accident in the schoolyard. Surprisingly, this was occurring just seven weeks following treatment with TempCanal.

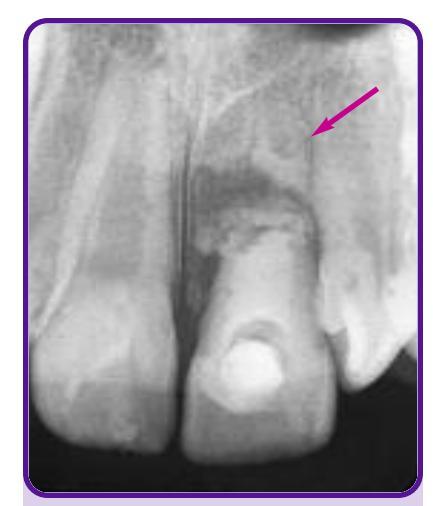
Figure J4 Shows healing and apexification. Note apexogenesis of the separated root tip. (November 1992)

We followed Jason closely and changed the TempCanal dressing on a regular basis. The tooth became firm once again, and we were hopeful for success even after two traumatic injuries. When Jason returned to the clinic in November 1992, a radiograph showed healing and closure of the apex and apexogenesis of the separated root tip (J4). The TempCanal dressing was removed and the canal was obturated with Pulpdent Root Canal Sealer using the Pressure Syringe with an 18-gauge needle. The tooth was restored with composite.

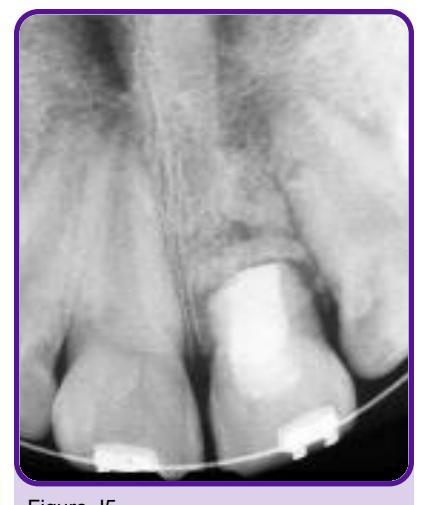
Figure J5 Shows canal obturated with Pulpdent Root Canal Sealer, apexogenesis of the separated root tip and orthodontic brackets in place. (February 1993).

Jason returned again in February 1993, and we were pleased to see total healing (J5)). The radiograph shows a well-sealed root canal and the formation of the separated apical root tip, which continued to develop.

As you can see from the radiograph, Jason is wearing braces. We were concerned that placing a bracket on the twice-traumatized tooth might cause root resorption due to the applied force and movement of the tooth. However, when we saw Jason more than $2^{1/2}$ years later in November 1995, the tooth looked great, and so did Jason (*J6 & J7*). We did note slight discoloration of the replanted tooth at this visit, which was most likely caused by the trauma, the breakdown of pulp tissue and the extravasation of blood into the dentin.

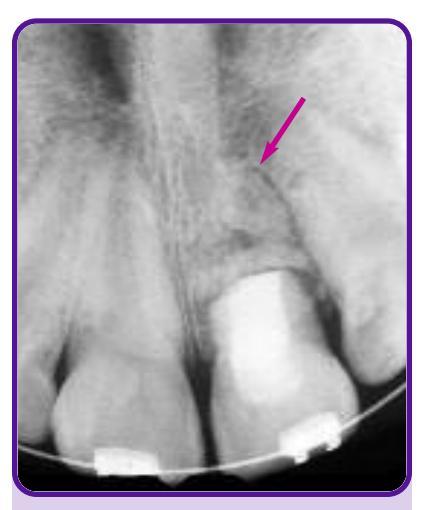
Figure J6 Radiograph taken over 2¹/₂ years following orthodontic treatment shows no sign of root resorption. Note that the separated tooth bud has fully developed into a mature apex and is probably vital. (November 1995) In November 1997, after his braces had been removed, Jason returned to the clinic to see if we could bleach his discolored tooth. The tooth was reopened, all the restorative resin was removed, the root canal sealer was cut back to 2-3 mm below the cervical line of the tooth, and the tooth was thoroughly cleansed with sodium hypochlorite and dried. A hard base was placed over the root canal sealer to prevent idiopathic rejection from the bleaching procedure.

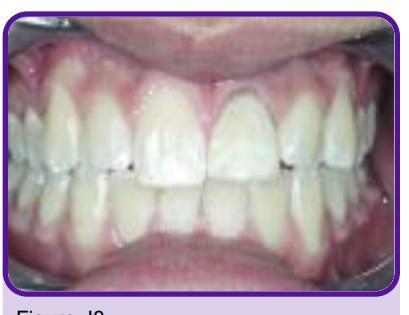
Figure J8 Photograph taken 6½ years after the first traumatic injury shows a natural color blend between the restored tooth and the adjacent central incisor. The slight gingival irritation is from the rubber dam clamp. (November 1997)

In a dappen dish, we made a mixture of 30% hydrogen peroxide solution and sodium perborate to form a thick bleaching paste, and placed it in the chamber. Heat was used to activate the bleaching material, so a damp cloth was placed over Jason's face for protection, and the unit light was placed close to the tooth. After ten minutes, the chamber was washed out, and a new mix of the bleaching paste was placed into the chamber and sealed with a hard setting cement. The tooth already appeared lighter.

Jason returned one week later, and we could see that the bleached tooth closely resembled the other central incisor. The tooth was reopened and the bleaching paste was cleaned out of the chamber. In order to give the tooth a natural appearance and prevent it from darkening again, the chamber was etched, and DenTASTIC adhesive primer and unfilled resin bonding agent were applied and light cured. This created a life-like translucency and esthetic effect that blended with the adjacent central incisor. The tooth was then restored with a tooth shade composite.

Figure J8 is a photograph taken upon completion of the restoration, six years after we started this case. Jason looks great, and we were all thrilled with the results.
